Rotokawa Development
Tikanga Ora Charitable trust
671 Puaiti Road, Waikite Valley

Geotechnical, Services and Earthworks Assessment Report

Reference 25594
Status ISSUE
Date 17/10/2024

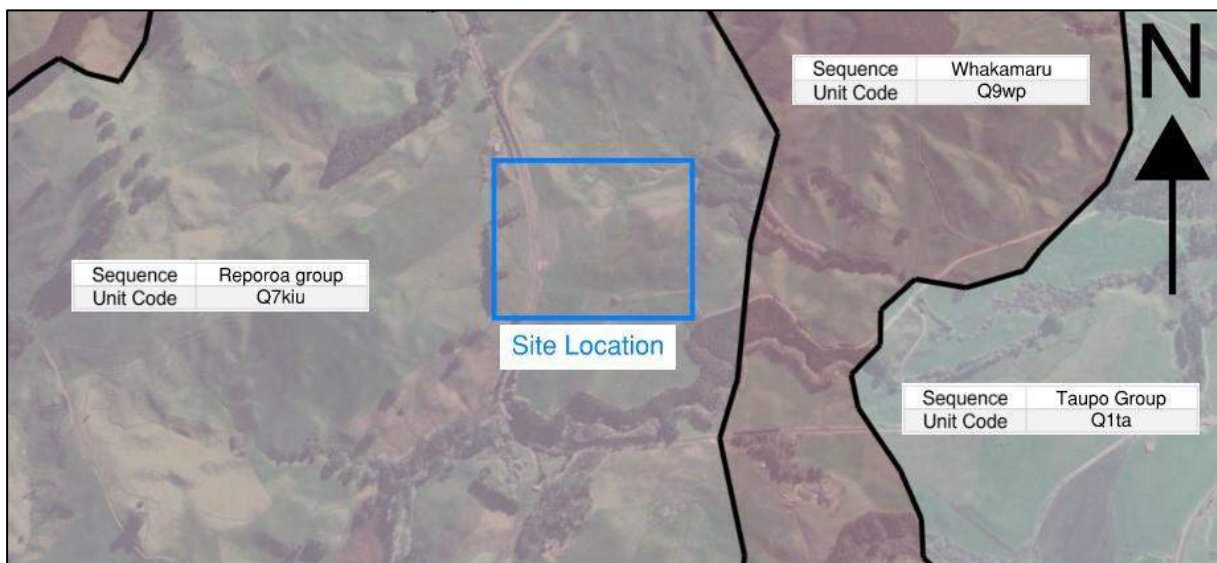
Figure 2. Geology of the site, image courtesy of Google Earth and Geyserview.

The geological maps for the area, (Leonard, Begg, & Wilson, 2010) and Briggs et al, 1996 indicate that the site is underlain by "Reporoa Group" sediments, from the "Rhyolite ignimbrite, crystal- and pumice-poor, pink, and yellow through to vapor-phase-altered at the top; minor fall deposits rock group: ignimbrite". Part of the geological map for the site's location has been reproduced in Figure 2.

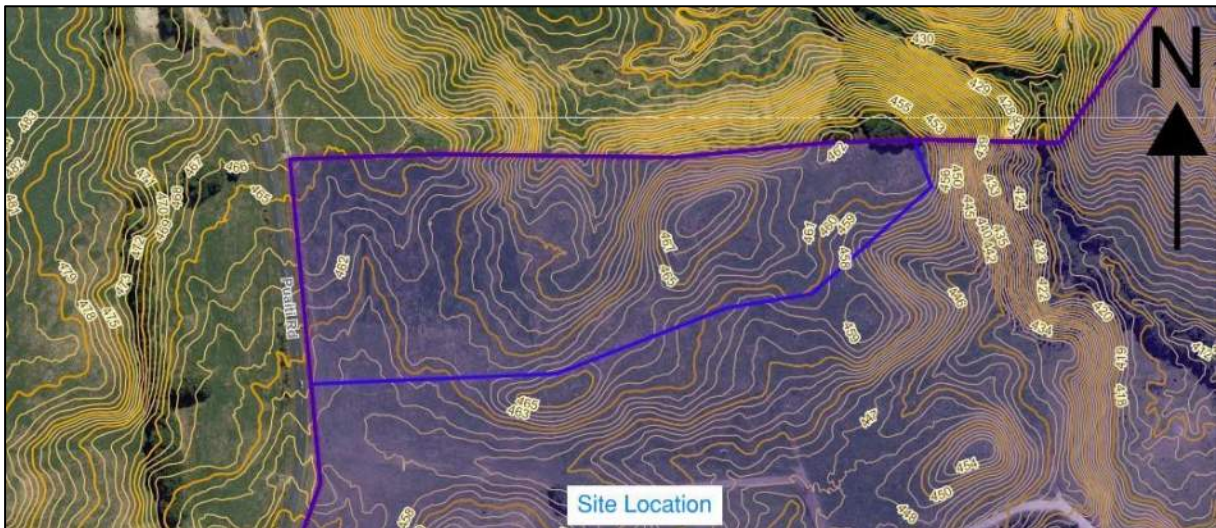
Figure 3. Aerial Image and Site Contours. Image courtesy of RLC contour map.

Site observations and the contour maps show that the slight undulations steepen to the east and drop approximately 25m down to a lower terrace. A stream is located another 5m lower than this platform to the northeast.

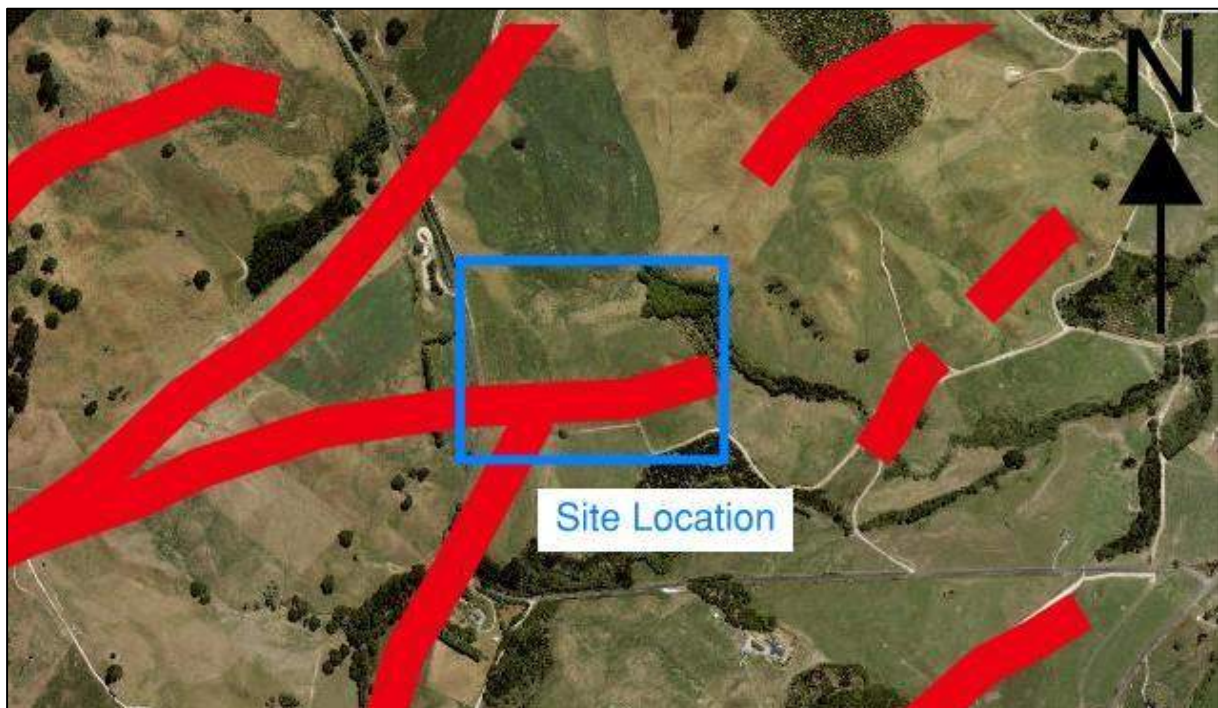
Figure 4. Aerial Image and Site Contours. Image courtesy of GNS active fault map.

The proposed site is located near the Puketerata Fault, which is a known normal fault with a recurrence interval of $\leq 2,000$ years. This relatively frequent seismic activity suggests that the fault could generate ground movements or earthquakes within that time frame. The presence of this fault has been considered in the design and the building locations have been moved outside of these areas.

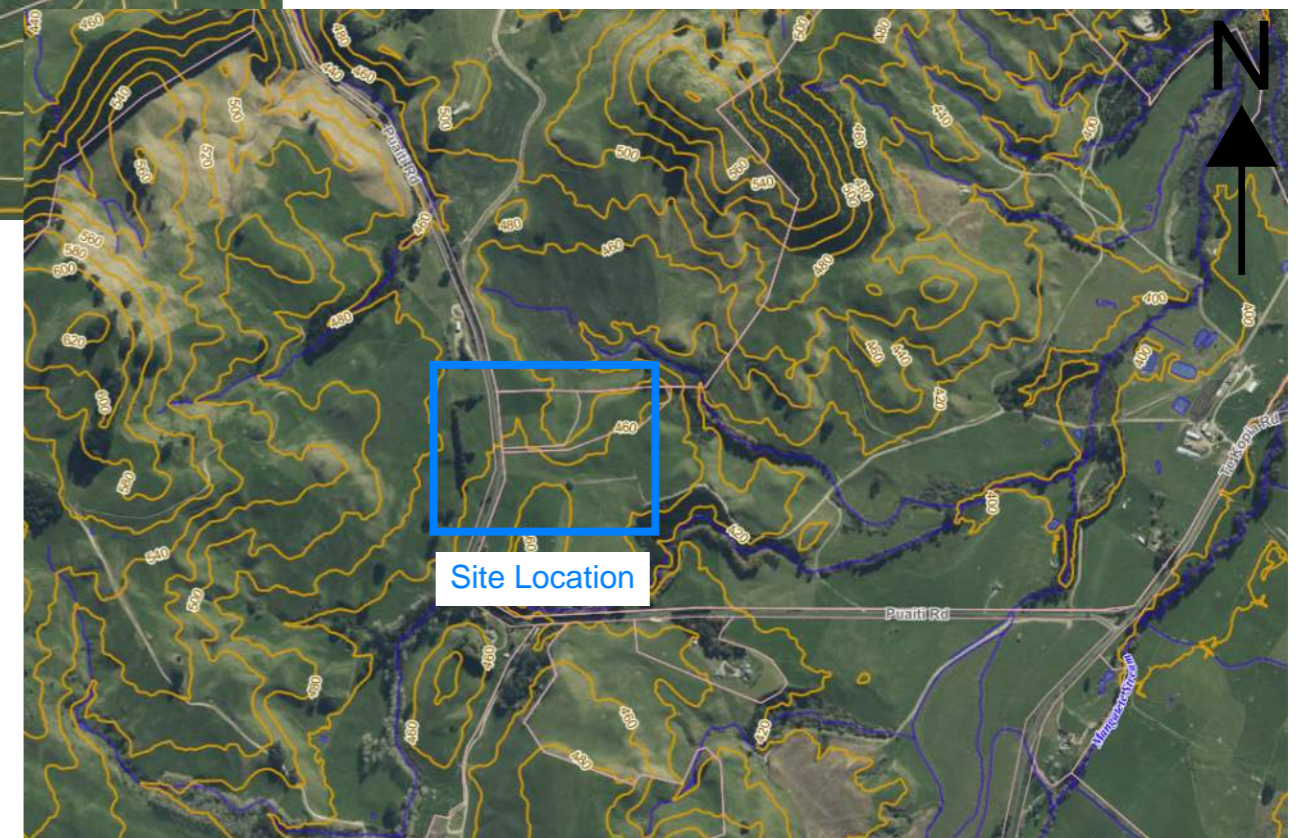
DRAWING NAME:	SITE LOCATION PLAN
PROJECT:	1590A STATE HIGHWAY 30, LAKE ROTITI

HA	Hand Auger (BSK)
HA	Hand Auger (CMW)

The test locations are presented on the test location plan in Appendix A, with the test results presented in Appendix B.
