Submissions on Plan Change 8 (Natural Hazards) Volume 1

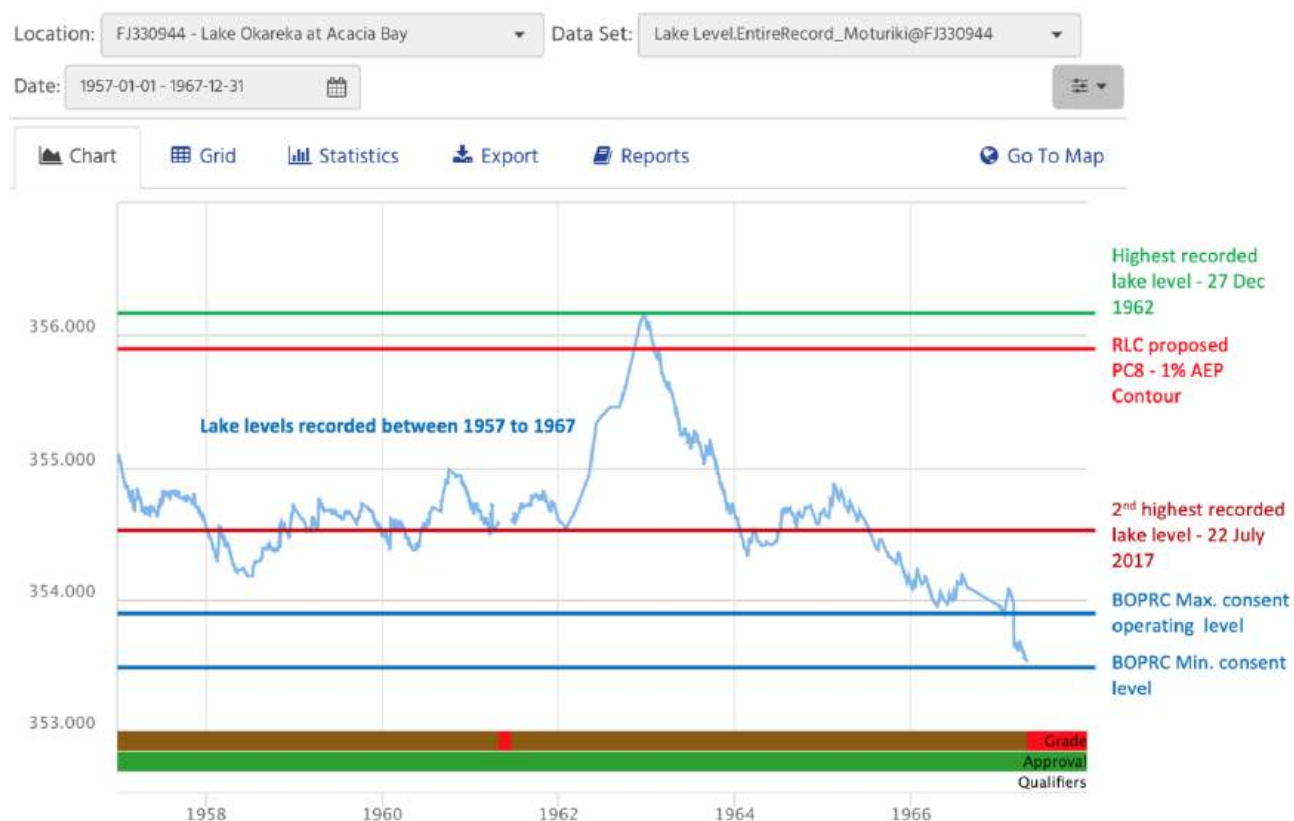
1962 Lake Ōkāreka Flood Event

- Date: Various dates throughout 1962
- Peak lake level: Estimated RL 356.157 metres (pre-instrumentation)
- Recovery time: 3 years for full restoration
- Affected properties: Multiple residences around lake perimeter
- Community response: Formation of resident action group
- Council response: Emergency pumping and planning for permanent solution

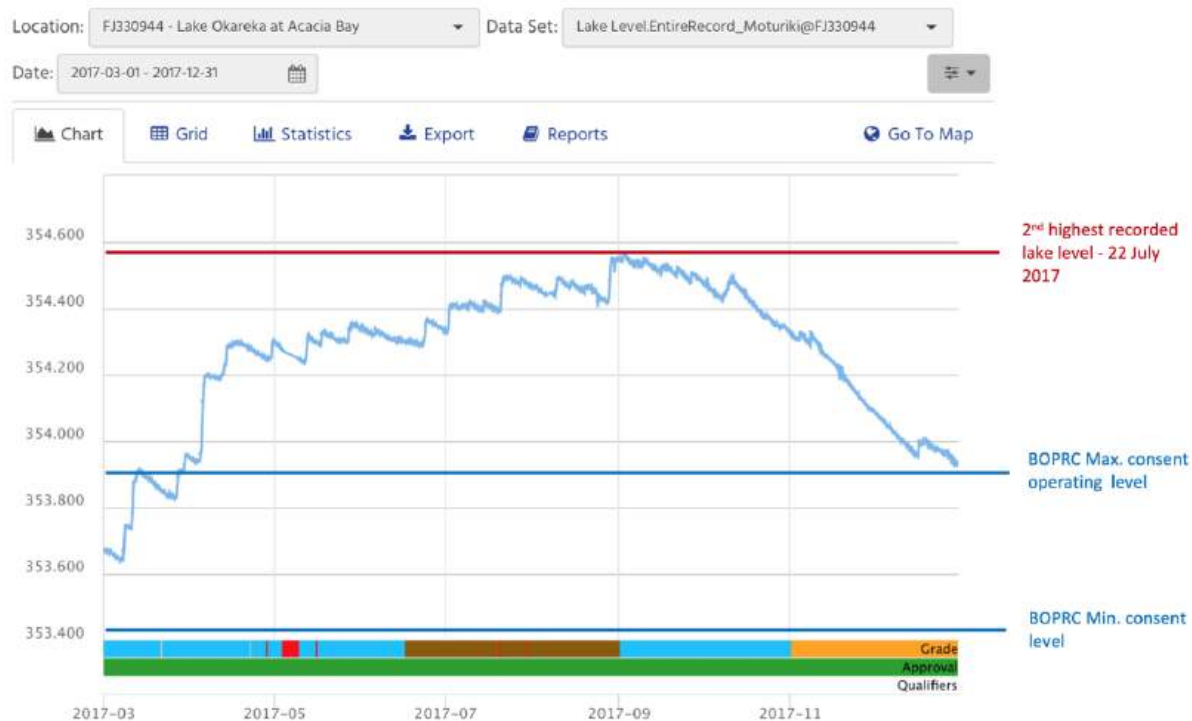
July 2017 – Excessive High Lake Levels

2017 Lake Ōkāreka Excessive High Lake Level Event

- Date: 31 July 2017
- Peak lake level: Estimated 353.9m RL
- Recovery time: 3 months for full restoration
- Council response: Emergency pumping and planning for an upgrade to the previous system

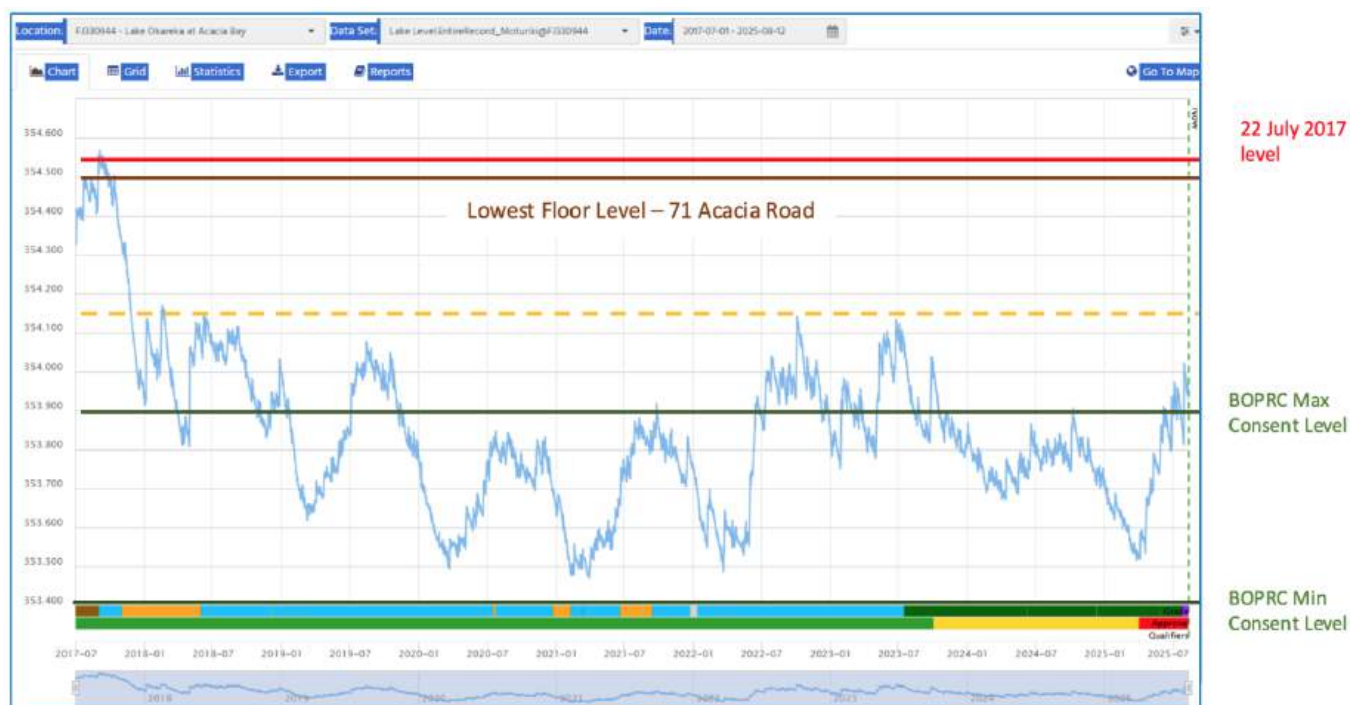
Lake Level Variations from July 2017 to July 2025

The graph shows the positive effect of the upgraded Lake Outlet Control System completed in 2021.

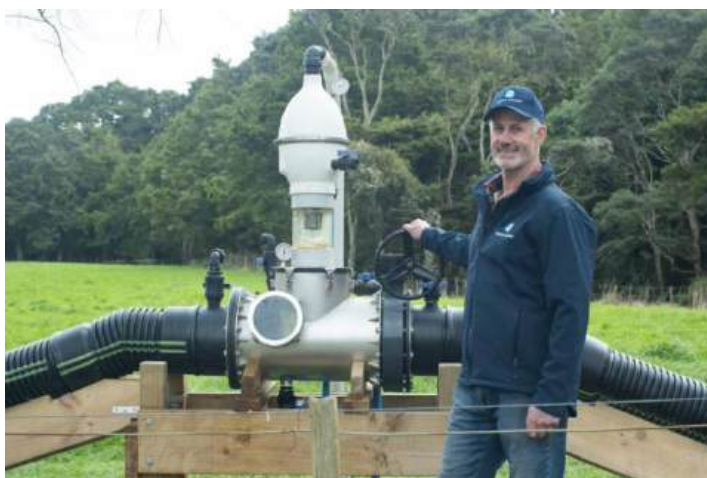
The image above is Tom Gardiner's self-priming siphon system, which uses a unique hydraulic vacuum primer to initiate water flow, harnessing basic fluid dynamics and gravity. The result is a robust, self-sustaining, and environmentally sound water management solution that requires neither motors nor electricity to function efficiently in the field.

A hydraulic vacuum primer ensures reliable siphon initiation and operation regardless of prevailing head conditions.

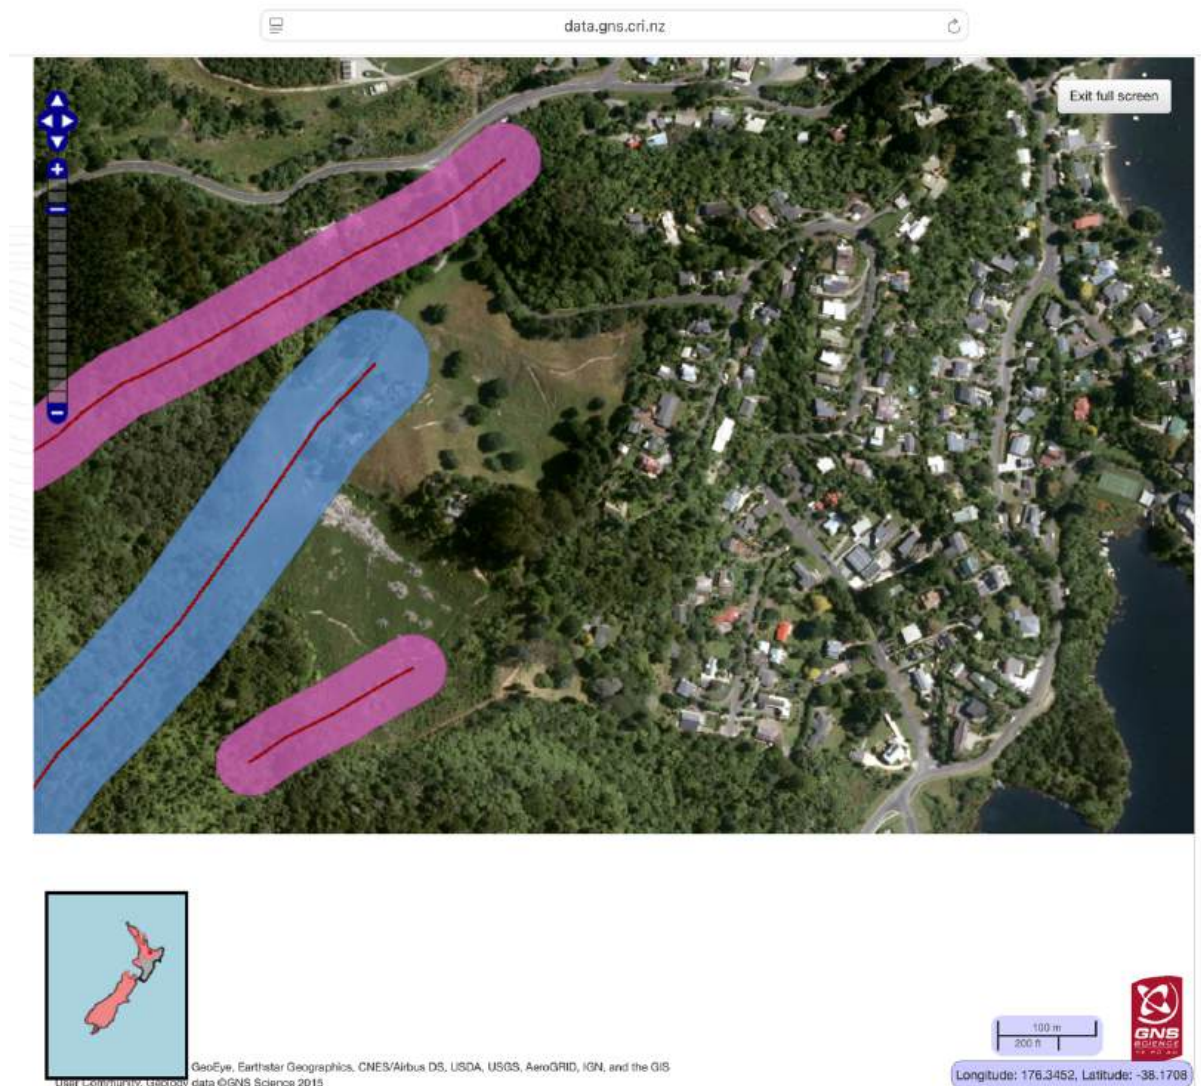
Map of proposed fault zones affecting 100A Okareka Loop Road, a Rurally zoned property with highly restrictive building and development covenants on its Title.

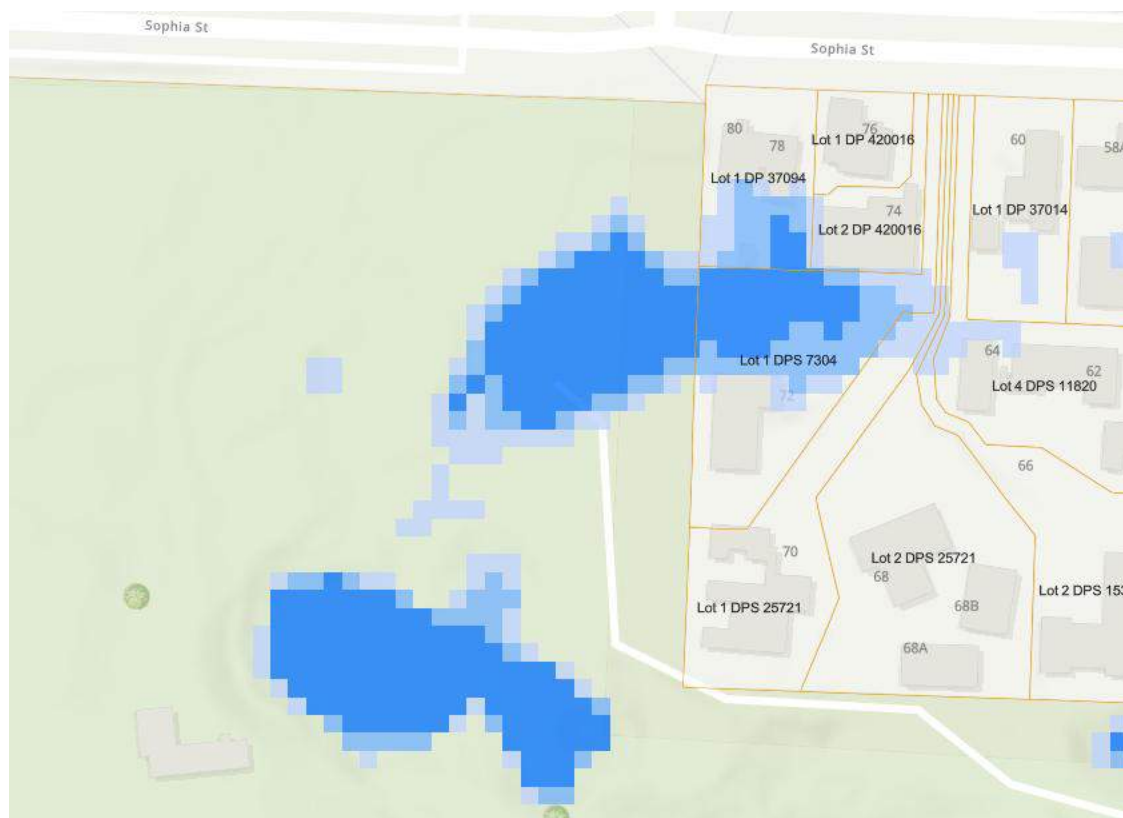
Figure 1. Pluvial Flooding shown utilising topographic data from RLC Plan Change 8 website.

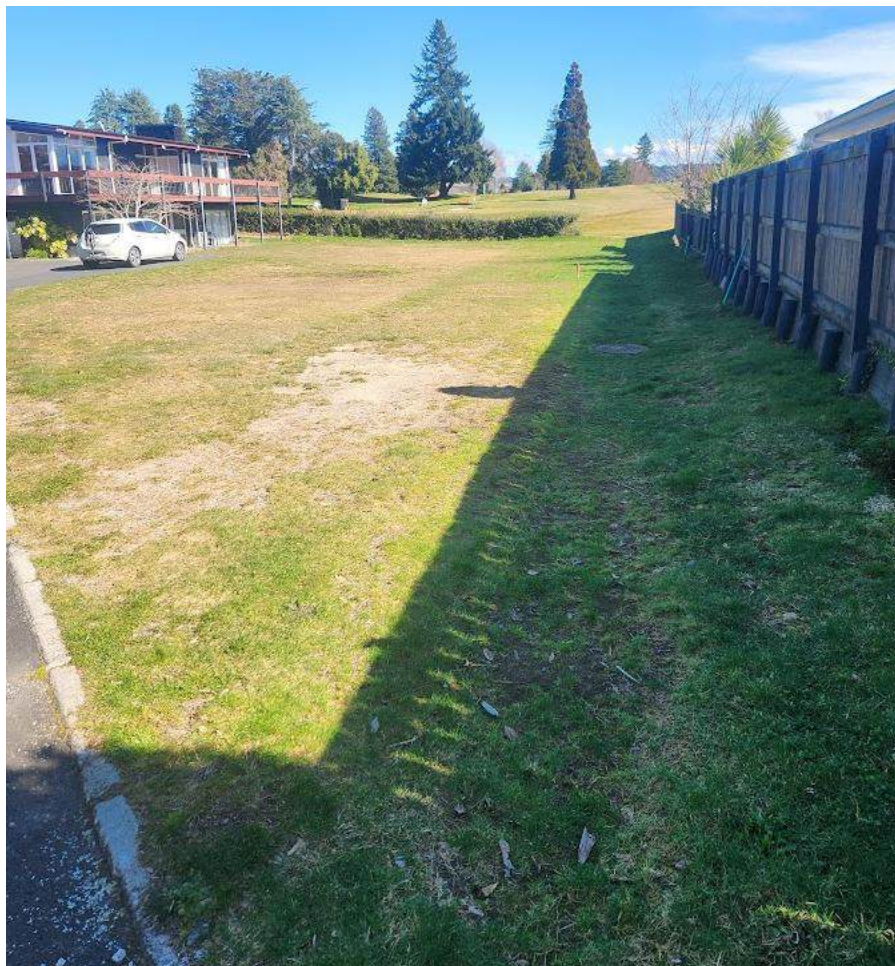
Figure 2. Grassed swale drain (shaded area) installed to consent conditions.

These mandated engineered earthworks will fundamentally and permanently alter the site's topography from the natural state that was captured by the Council's 2020 LiDAR survey. The Council's model, therefore, is simulating rainfall on a version of the property that will legally cease to exist once development proceeds. The correct baseline for any hazard assessment is the consented future ground level, which incorporates the raised platforms and the formed stormwater swale. This 'consented environment' is the factual and legal reality that must be considered for 72 Sophia Street.

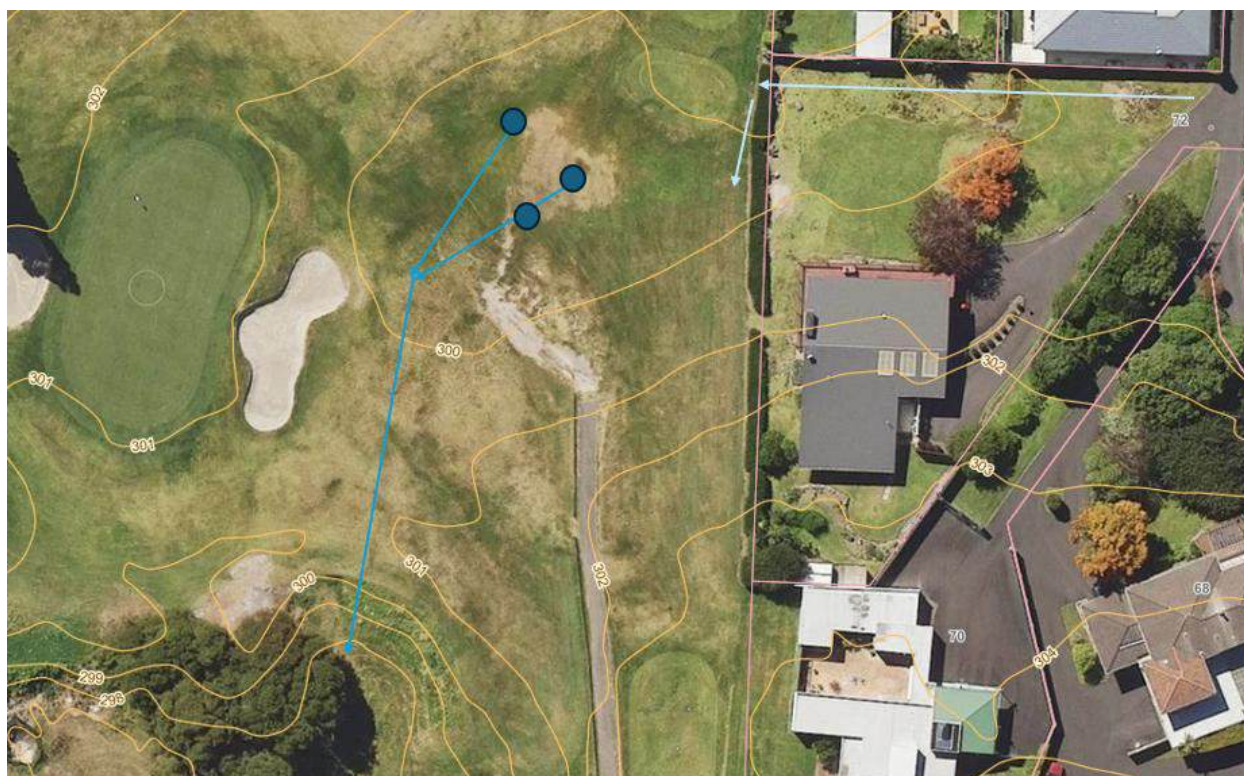
Figure 3. Plan view broadly showing existing stormwater controls unaccounted for in Council Pluvial Flood Report

Course, and its drainage is influenced by multiple cesspits and stormwater drain located on the golf course, which are not part of the Council's network and are therefore not included in the model. This introduces a further, un-quantified error into the model's simulation for this specific location. Figure 3 shows a broad plan of stormwater infrastructure. Figures 4, 5 and 6 below show the location of this infrastructure.

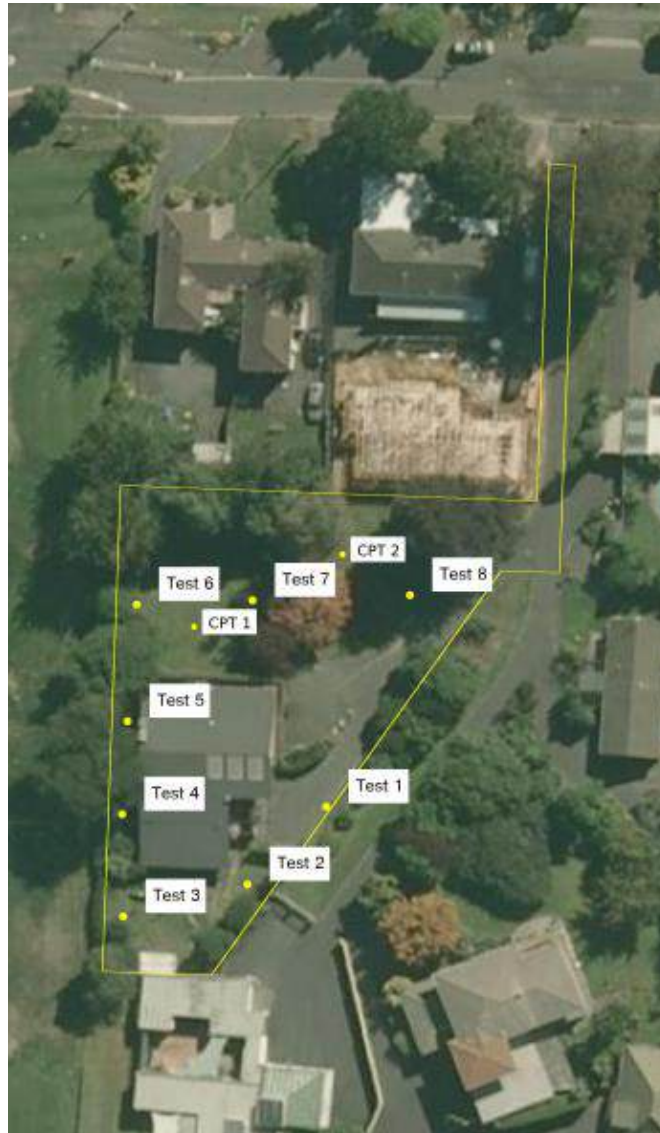
Figure 1: Site Plan

The site is accessed via a right of way from Sophia Street. There is a lower level to the north, with a garage, at the lower level, and the existing house occupying a higher bench on the site. To the West is the Rotorua Golf course. Some of the nearby area is geothermally active, with comment below on potential geothermal impacts and mitigation.

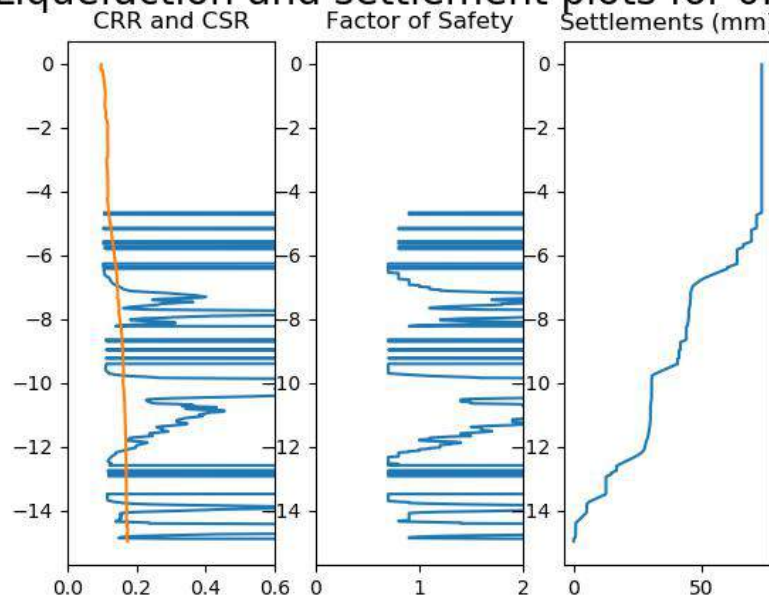
Figure 3: ULS Settlement Graph - CPT 1

The SLS earthquake produces a settlement of approximately 0mm.

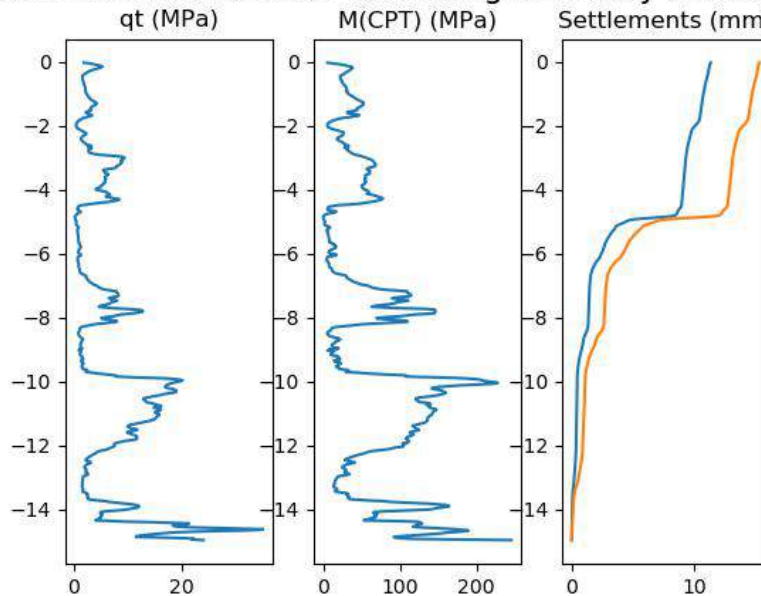
Figure 6: Settlement under static load

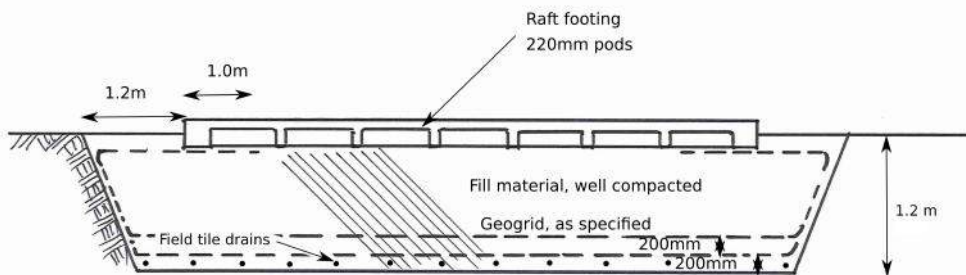
Figure 7: Undercut and backfill for raft footing

Testing shall be undertaken when the hole is open, and the subgrade shall achieve a 200kPa bearing capacity for a further 0.8m below the undercut depth. Any localised soft spots are to be excavated and recompacted if the found material is suitable, or replaced with competent fill material.

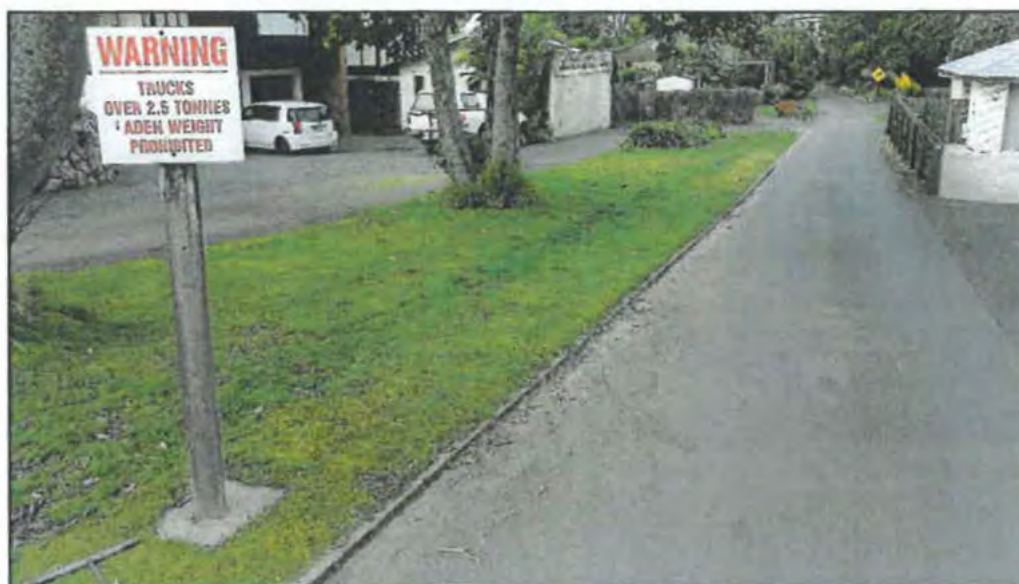
Photo 1 – Existing access

Access to 72 Sophia Street is gained via mutual right of way easements for which the Client owns part of. This access currently services eight properties. The access functions as a one-way loop road with an average lane width of 3.0m. A vegetated medium strip divides each lane. The proposed subdivision would be accessed at the end of the one-way loop. Photo 1 below shows the current right of way (ROW) layout and condition.

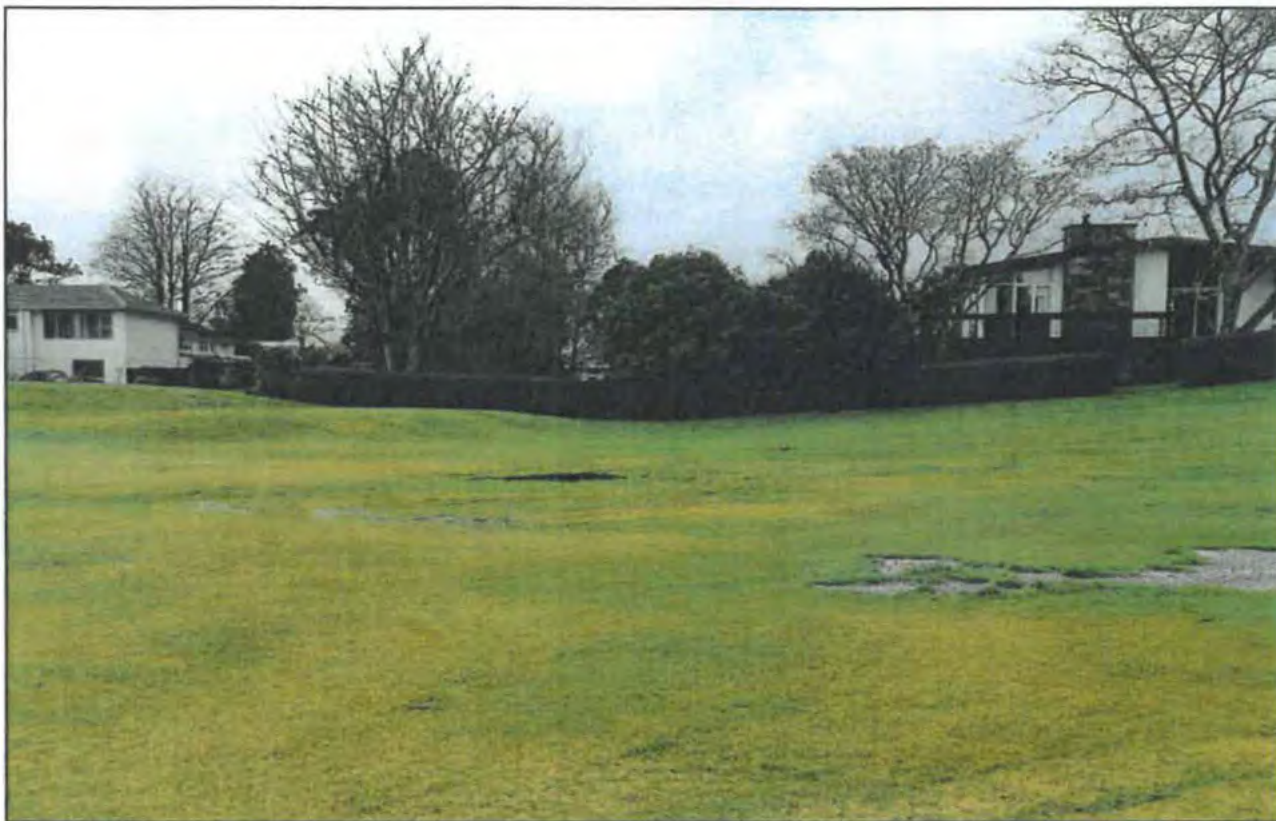
Photo 2 – Blind gully in golf course (cesspit located near small puddle)

The northern half of the proposed subdivision is located within the head of a shallow gully. This gully has a low crest within the golf course to the west making it blind. As such, stormwater currently ponds within the golf course adjacent to the property during rain events. A cesspit located within the golf course assists drainage of the ponding area, this drops water into a ø300mm stormwater pipe which discharges into an adjacent crater. During heavy rain events ponding extends into the northern half of the subdivision area. Photos 2 and 3 below show the ponding area in the golf course and low-lying area within the proposed subdivision.

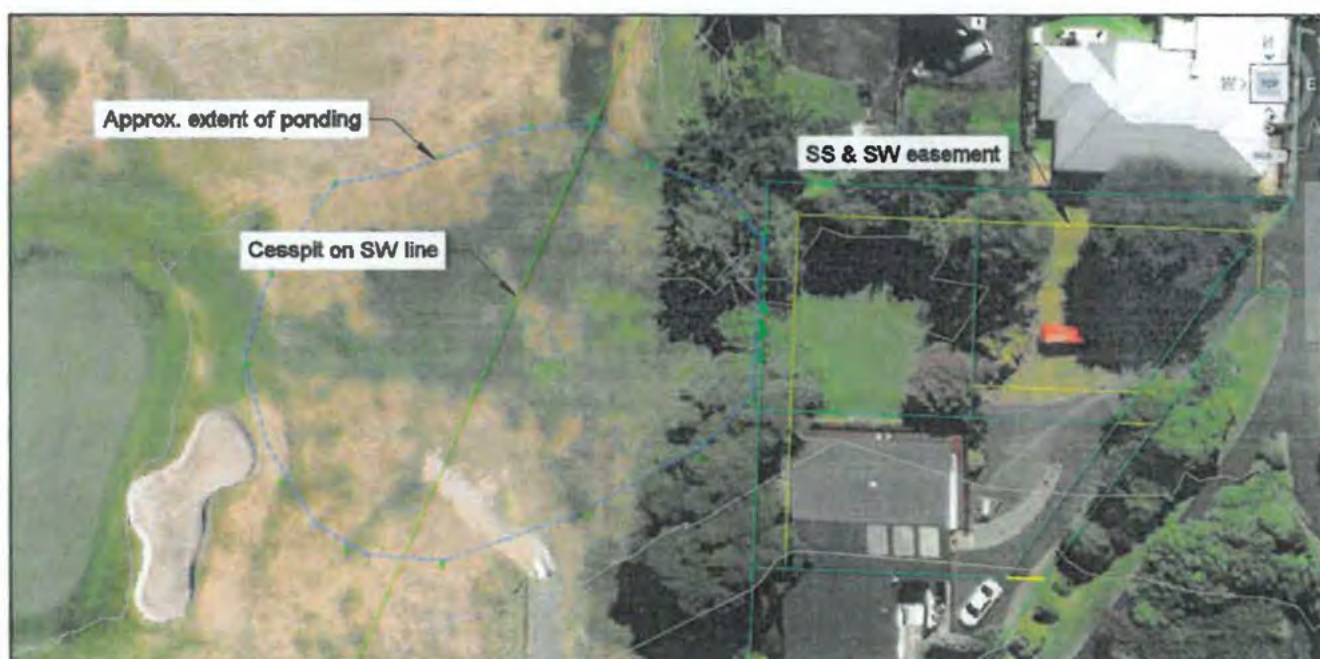
Figure 2 – Approximate extent of ponding

Indicative stormwater modelling has been undertaken for the subdivision to ascertain the depth of ponding within an AEP 1% storm of one-hour duration. Existing soakage was assumed to be at 100% capacity. The contributing catchment was 3.39 ha and a composite Rational Method coefficient of 0.378 used which reflects post development conditions. Rainfall data was taken from HirdsV3 with a 2.1°C temperature increase. The total volume of water for such an event is estimated to be 1028m³. Assuming the existing stormwater pipe is at capacity, ponding is confined to the golf course and no soakage occurs, maximum ponding depth at boundary is estimated to be 0.59m. The approximate extent of ponding is shown in Figure 2 below, the water surface has an elevation of 300.46m RL (Moturiki Vertical Datum 1953).

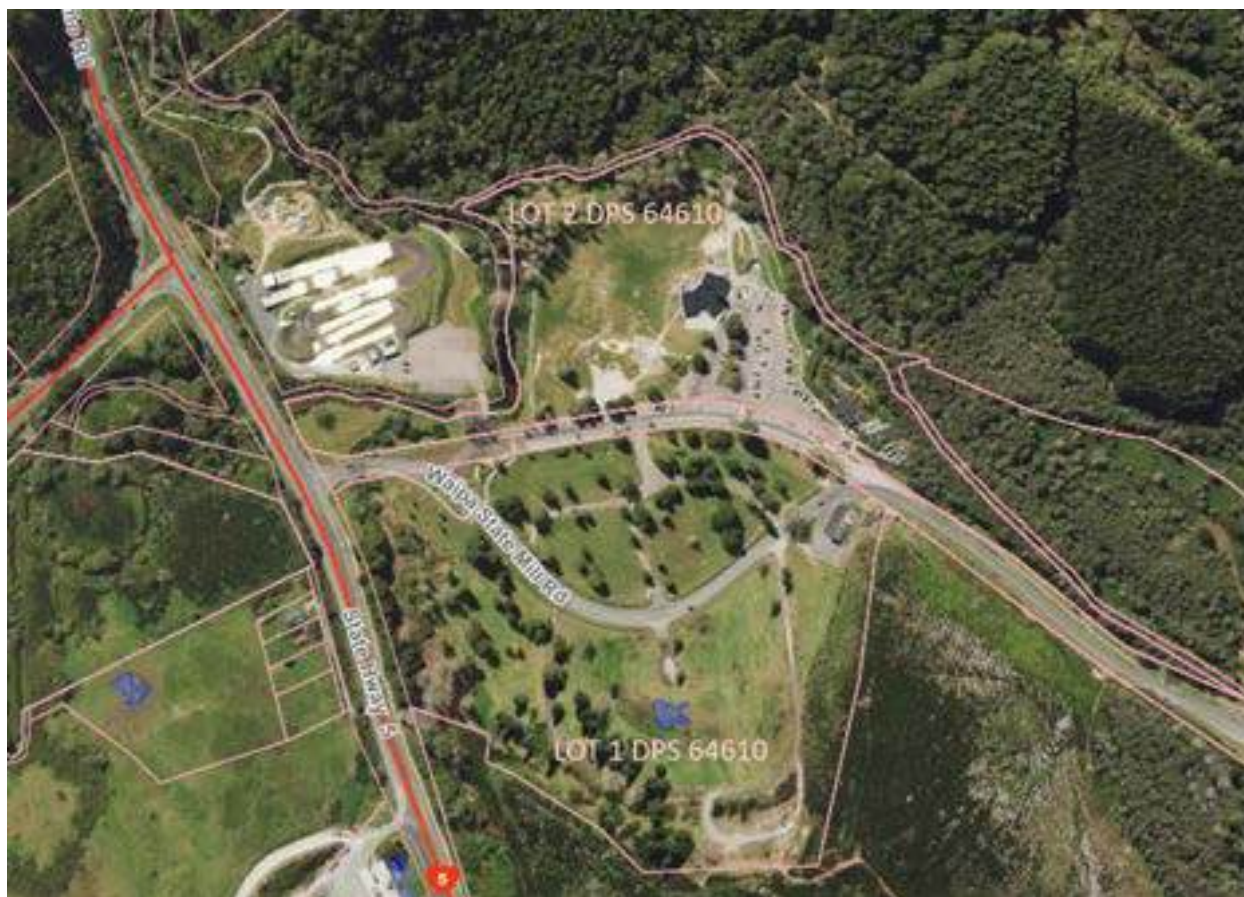
Figure 1. Property lots owned by Red Stag Investments (Lots 1 & 2 DPS 64610)

This submission relates specifically to the land parcels (Lots 1 & 2 DPS 64610) owned by Red Stag Investments located at Waipa State Mill Road and the Waipa Bypass Road, Rotorua. This extensive site accommodates the entirety of the Red Stag Investments public amenity areas operations, associated infrastructure, and areas

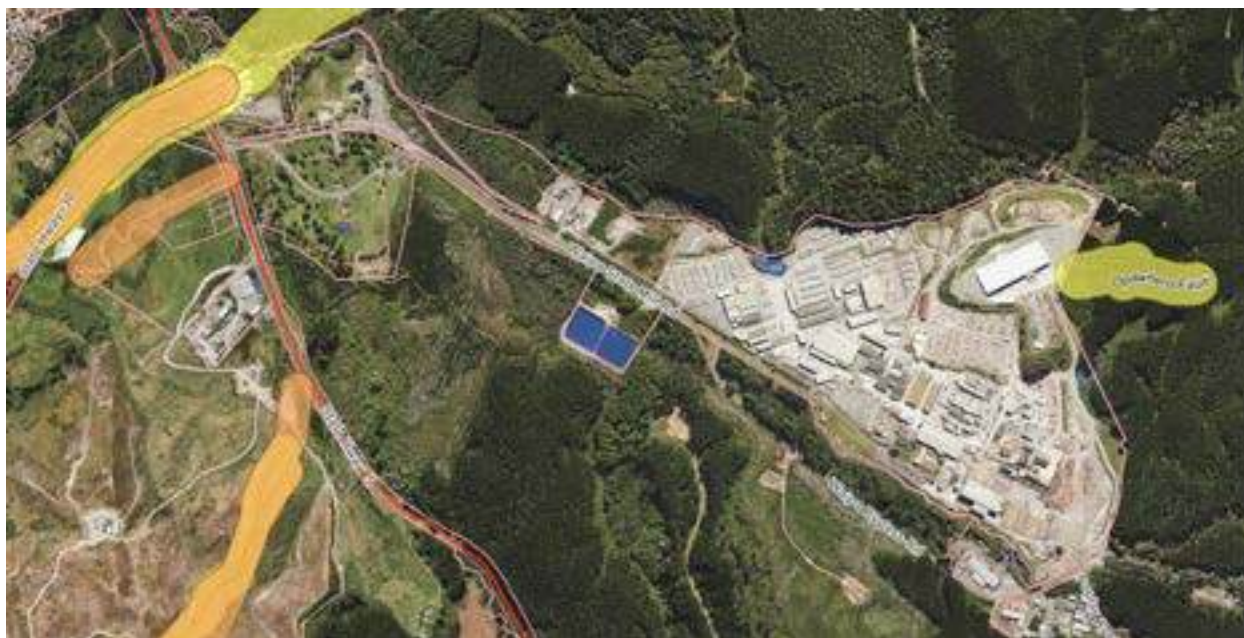
Figure 2. Previous Fault Mapping (pre-2025 GNS update) showing no faults on Red Stag's operational land.

The most significant issue for the Submitter is the fundamental change in the perceived natural hazard profile of its land. Under the previous planning framework, which relied on the GNS 2010 fault mapping (Villamor et al., 2010), the operational area of the Red Stag site was not identified as being crossed by any active fault traces.¹ Figure 2, derived from the Council's Geyserview mapping prior to the 2025 update, clearly illustrates this absence of mapped faults on the core industrial site.

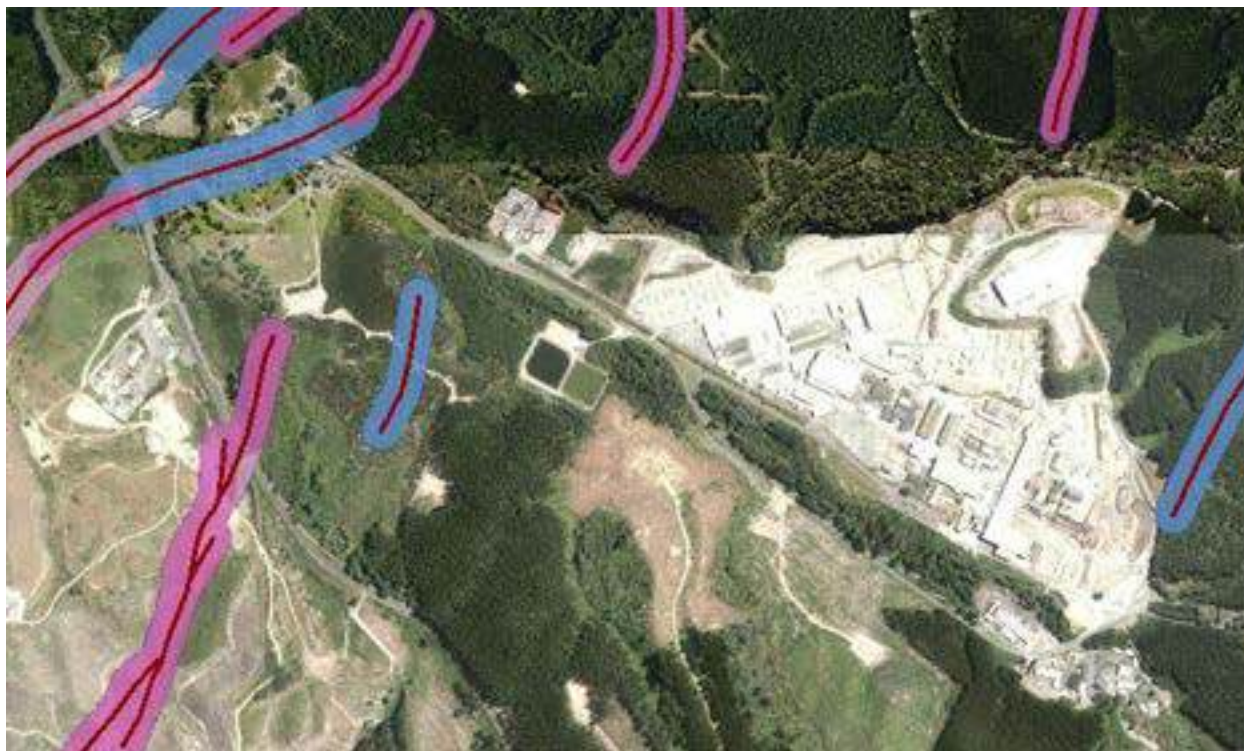
Figure 3. Updated 2025 GNS Mapping showing a newly identified fault trace and Fault Avoidance Zone crossing Red Stag's land.

In stark contrast, the newly proposed framework is based on the GNS Science Consultancy Report 2025/02 LR, which utilizes updated high-resolution LiDAR data.¹ This new assessment has resulted in the mapping of a fault trace directly across the Submitter's property, as shown in Figure 3.

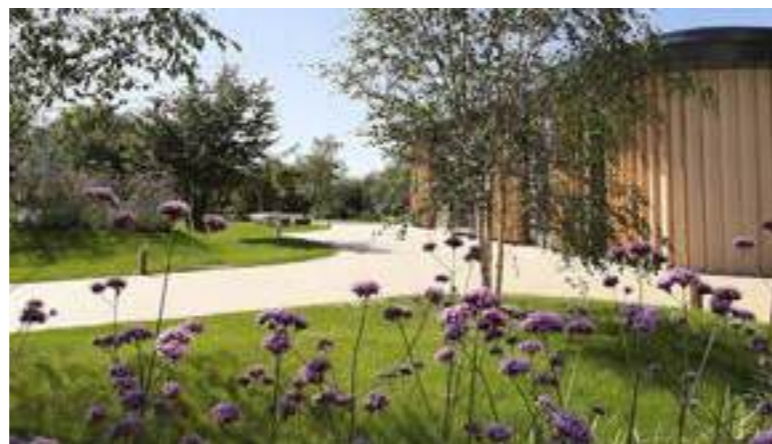
LANDSCAPE STORMWATER SWALES

There is opportunity to use a selection of naïve planting to enhance the forest park feel of the location. The use of stormwater swales gardens to the perimeter of carparks will allow a natural filtration of any heavy metals washed from the carparks and allow for some flood retention ability in high rainfall events.
